# LAS VIRGENES - TRIUNFO JOINT POWERS AUTHORITY AGENDA 899 North Kanan Road, Oak Park, CA

RESPONSE TO REQUEST FOR ALLEGED VIOLATION REVIEW - LAS VIRGENES MUNICIPAL WATER DISTRICT, TAPIA WATER RECLAMATION FACILITY, 731 MALIBU CANYON ROAD, CALABASAS, CA (ORDER NO. R4-2010-0165, NPDES PERMIT NO. CA0056014, CI NO. 4760)

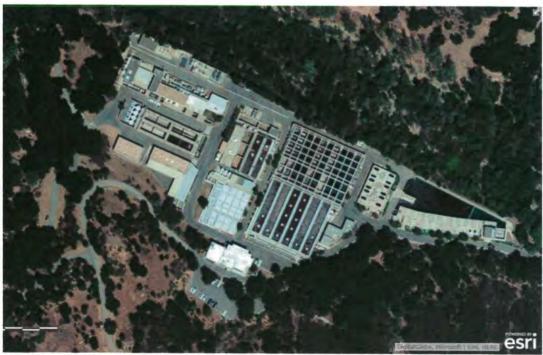
The Facility provides tertiary level treatment of wastewater. Preliminary treatment consists of two bar screen, three shredders, and two grit chambers. Foul air is pumped to carbon towers for odor control. The influent is then directed to the five primary clarifiers, then to the six biological nutrient reduction (BNR) units divided into two identical liquid trains in parallel incorporating both anoxic and aerobic zones for nitrification and denitrification. The mean cell residence time is 6 hours. Mixed liquor from the BNR units then undergoes sedimentation in one of the ten secondary clarifiers. Secondary effluent is then routed through one of twelve dual-media filters consisting of four feet of anthracite and one foot of gravel, chlorination and de-chlorination chambers, and dosed with ammonia to control dichlorobromomethane (DCBM). During peak wet weather flow, wastewater is diverted to a balancing pond on the east side of the facility, adjacent to the chlorine contact chambers. The balancing pond also collects storm water runoff from the site.

Figure 1 – Aerial View of Tapia Water Reclamation Facility (Source: ArcGIS Explorer Online, August 26, 2014)

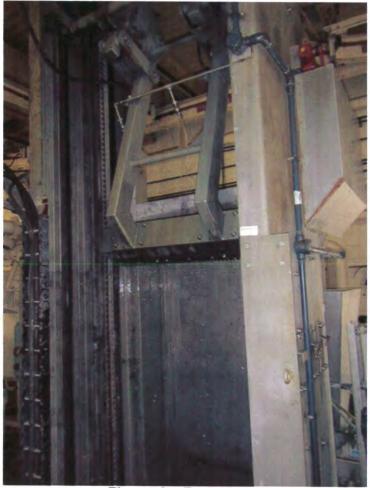
Figure 2 - Bar screen

Edgar Cuaresma, Tapia WRF's Chief Plant Operator walked us to the head works. At the time of inspection, there was one bar screen in service (see Figure 2 below). Mr. Cuaresma indicated that this is typical and that they are switched out every 24 hours.

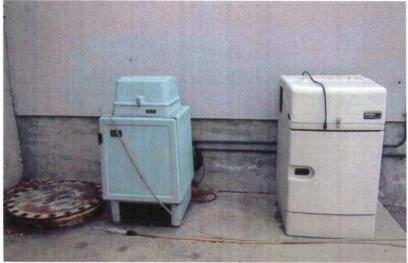
Figure 3 - Influent sampling location

Mr. Cuaresma clarified that the influent sample is taken prior to preliminary treatment. One of the compositors was unplugged. Mr. Cuaresma did not note whether that compositor was still in use and what it was used for. We opened the other and it was refrigerated (left in Figure 3 below). Foul air is pumped to the carbon towers shown in Figure 4 for odor control. There are two sets of towers at the facility.

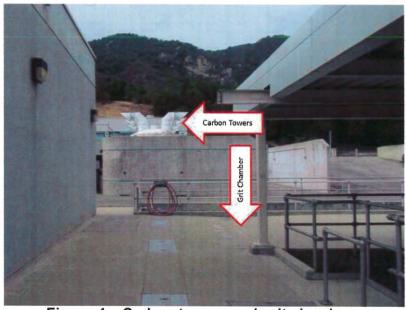
Figure 4 - Carbon towers and grit chambers

Also in service during the inspection was one of three shredders. The grit chambers were below ground and covered so were not observed during the inspection, but Mr. Cuaresma said that the Facility has two grit chambers and that only one was operated at a time. There is no flow equalization at the plant; because Malibu creek runs along the northern perimeter of the Facility, there is no physical space to add it prior to clarification.

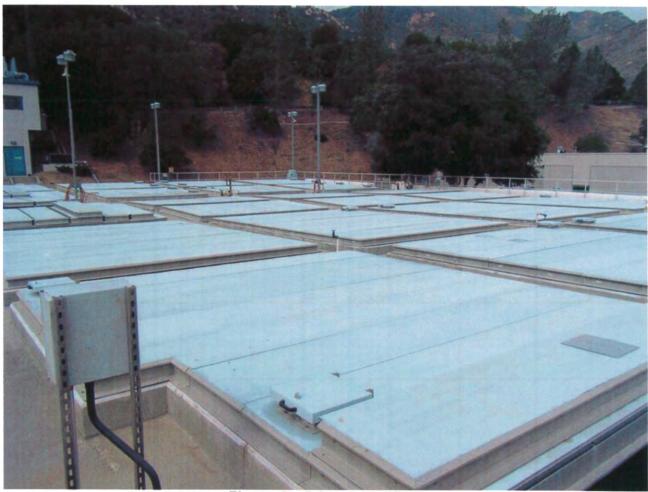
Figure 5 - Primary clarifiers

There are five covered, rectangular primary clarifiers at the Facility. Mr. Cuaresma noted that to increase the amount of carbon for the microorganisms in the biological nutrient reduction (BNR) units, only two clarifiers, Nos. 4 and 5 were in service. This is going to increase the solids loading to the BNR and subsequently to the secondary clarifiers. Additionally, one was off-line undergoing maintenance to repair corrosion and to increase its lifespan.

Ms. Mustain noted that there was no sound coming from the skimmers and Mr. Cuaresma said that this is typical.

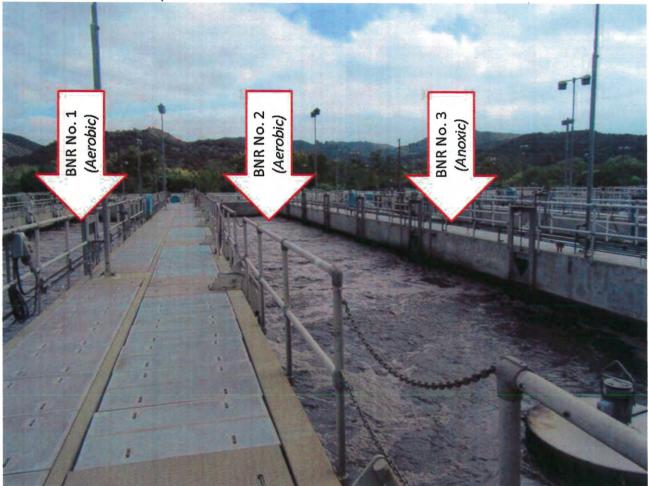
Figure 6 - Biological Nutrient Reduction Units Nos. 1, 2, and 3

After the primary clarifiers, the wastewater moves through the BNR units. There are six BNR units divided into two identical parallel treatment trains.

The wastewater is recirculated three times through the treatment trains. The facility is intentionally carrying more solids since it upgraded to include denitrification. Currently, there are >3000 mg/L total solids in the mixed liquor. The operators try to maintain dissolved oxygen (DO) at 2.4 mg/L in BNR units Nos. 1 and 6. Ms. Mustain observed the DO reading in BNR unit No. 1 was 2.23 mg/L during the inspection. The operators try to maintain the DO in unit Nos. 2 and 5 between 2.75 and 2.8 mg/L. DO is typically controlled by supervisory control and data acquisition (SCADA), but can also be controlled manually if necessary. The facility was running all six units during the inspection and Mr. Cuaresma opined that the facility is currently at capacity for the BNR system. BNR units 3 and 4 have post-anoxic<sup>1</sup> zones and units 1, 2, 5, and 6 are fully aerated.

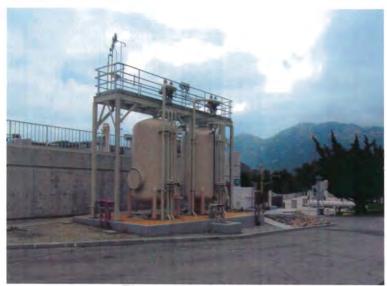
Figure 13 - Ammonia

Before viewing the post-secondary treatment processes, we walked by the chemical storage area. The facility stores sodium hypochlorite, sodium bisulfite, and alum. All have secondary containment. We also saw the ammonia tanks (ammonia is added back in for control of chlorine disinfection byproducts). Staff did not note the form or dose rate of the ammonia.

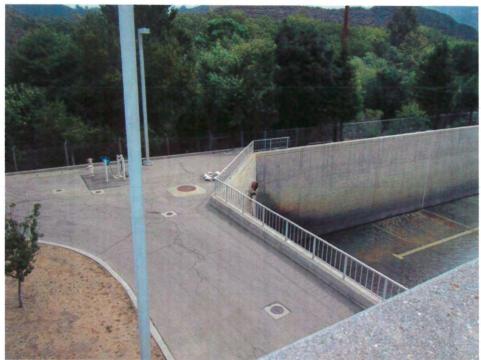
Figure 14 - Storm water pipe that drains into the balancing pond

The balancing pond lies immediately adjacent to the chlorine contact chambers. Because of shallow groundwater conditions, the facility must maintain 3 feet of water in the pond at all times so it doesn't float. The balancing pond is utilized at times of peak flow and unacceptable effluent quality.

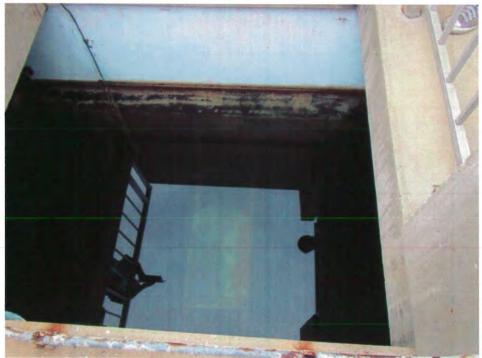
Figure 16 - Sampling location for coliform

The chlorine contact chambers are covered. According to Mr. Cuaresma, there are 5 chlorine contact channels in a serpentine formation and each channel is 260 feet in length. The Facility takes its total coliform, fecal coliform, and E.coli monthly grab samples prior to dechlorination.

Water Board staff observed the continuous-read meters for total residual chlorine, sodium bisulfite, and turbidity. When Water Board staff attempted to check the chlorine reading, one of the operators was in the middle of calibrating the meter. However, Ms. Mustain noted the concentration of the residual dechlorination agent, sodium bisulfite, was 2.51 mg/L. The turbidity reading was 0.68 NTU. Later when Water Board staff took a grab sample, the pH was 7.29, turbidity was 0.86 NTU, and the total residual chlorine was 0.01 mg/L. During the inspection, no other samples were collected because the Discharger has not turned on the compositor. Water Board staff will perform a split from the compositor at a later date.
