# **U.S. Environmental Protection Agency Region 9**

## **Malibu Creek & Lagoon TMDL for Sedimentation and Nutrients to address Benthic Community Impairments**

**Draft December 2012**

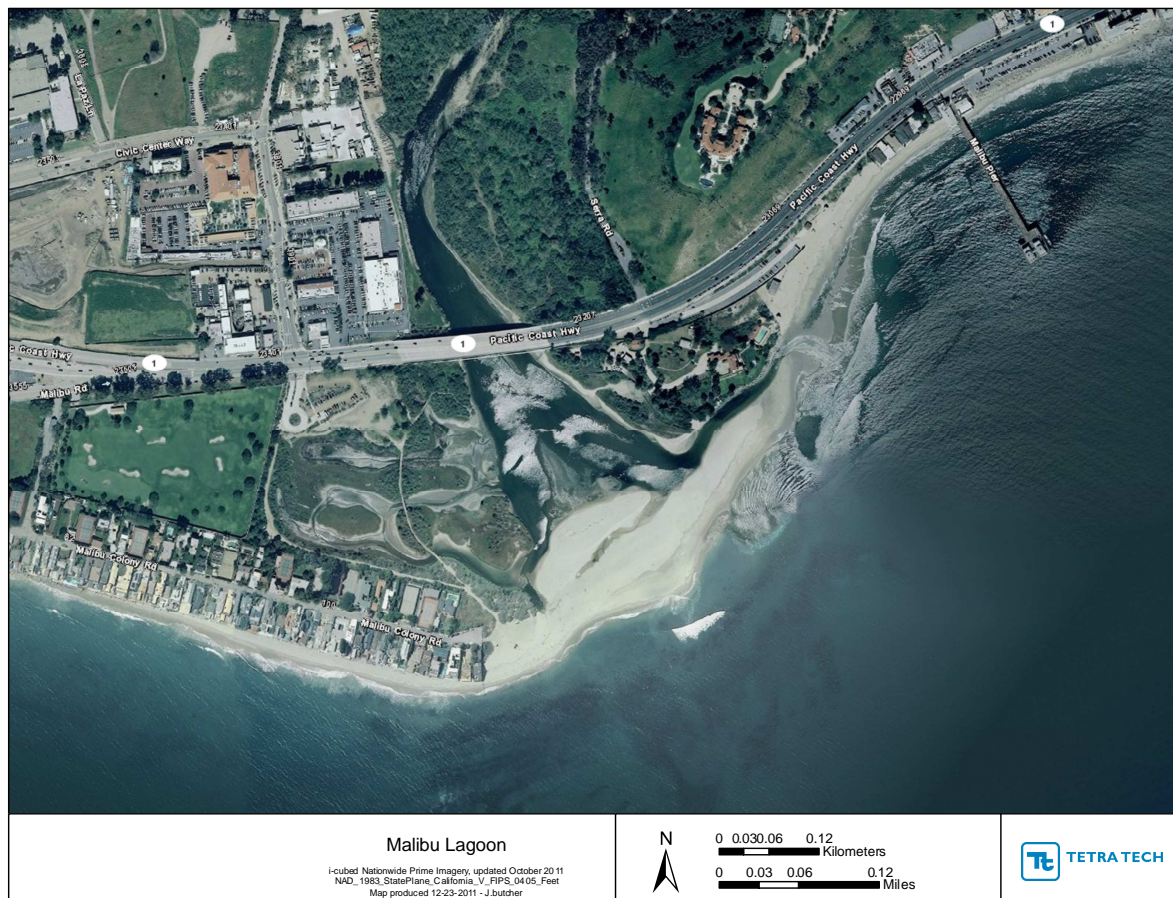
**Figure 4-3. Malibu Lagoon in October 2011**

Malibu Lagoon occupies a small prism at the confluence of Malibu Creek with the Pacific Ocean at Malibu Beach (Figure 4-3). Like most southern California estuaries, Malibu Lagoon is open to the ocean on an intermittent basis, with mouth closures due to coastwise sand transport. The image from October 2011 shows a small outflow occurring at the eastern end of the beach. The morphology of the current Lagoon is constrained by the Pacific Coast Highway, the Malibu Civic Center, and areas of fill (including a golf course) between the Pacific Coast Highway and the beach.

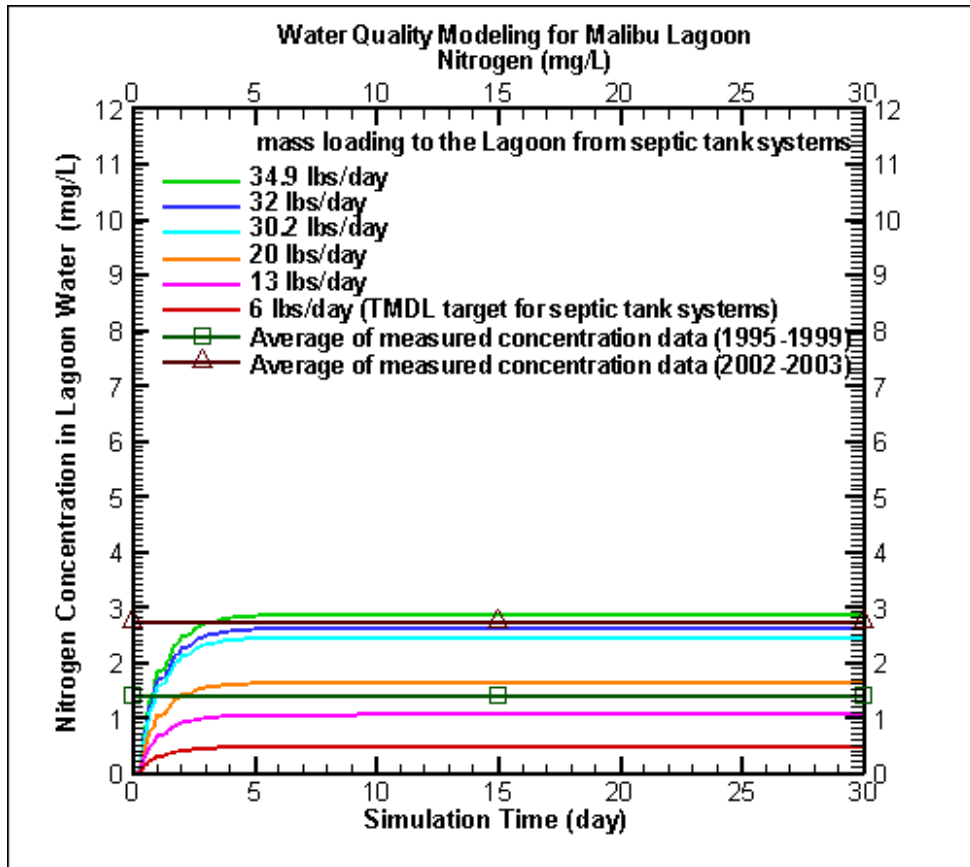
<sup>e</sup> the nitrogen mass loading based on the commercial load from each OWDS and the residential load with an average concentration of 45 mg/L from OWDS were used in the model. Staff estimated the nitrogen mass loading to Malibu Lagoon by using Questa numerical model results.

Figure 5-1. Nitrogen concentrations in Malibu Lagoon Resulting from Different Mass Loadings (Lai, 2009)

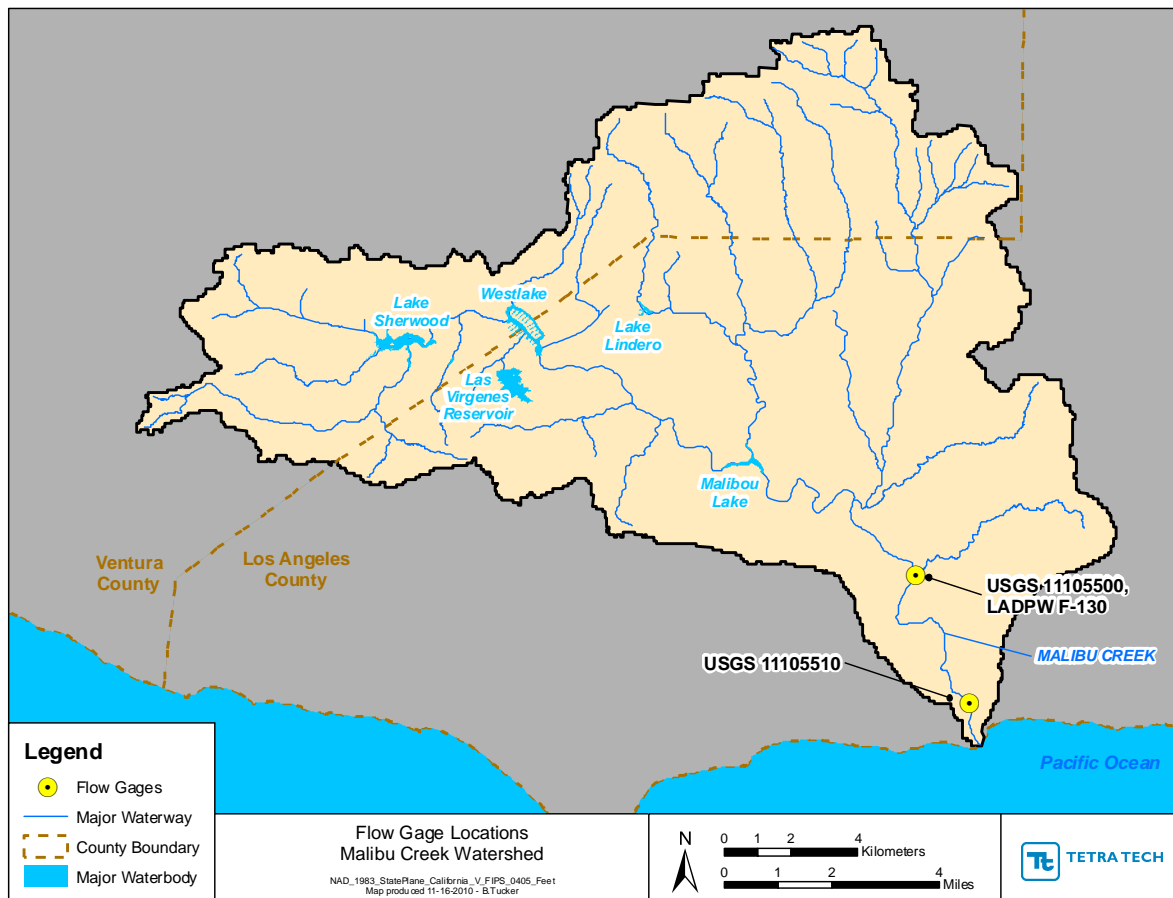
**Figure 6-1. Locations of Flow Gages**

Stream flow monitoring along Malibu Creek is limited to the two gage locations shown in Figure 6-1. The flow gage near Crater Camp (USGS 11105500; LACDPW F-130) contains the longest period of record. USGS operated this gage between February 1, 1931 and September 30, 1979, after which LACDPW took over operation and continues to monitor the gage to the present. (Records through the end of WY 2009 have been released as of this writing.) The second flow gage in the Malibu Creek watershed is USGS 11105510, an active gage located near the mouth of the river, upstream of the Lagoon. This gage has only been in operation since December 6, 2007.

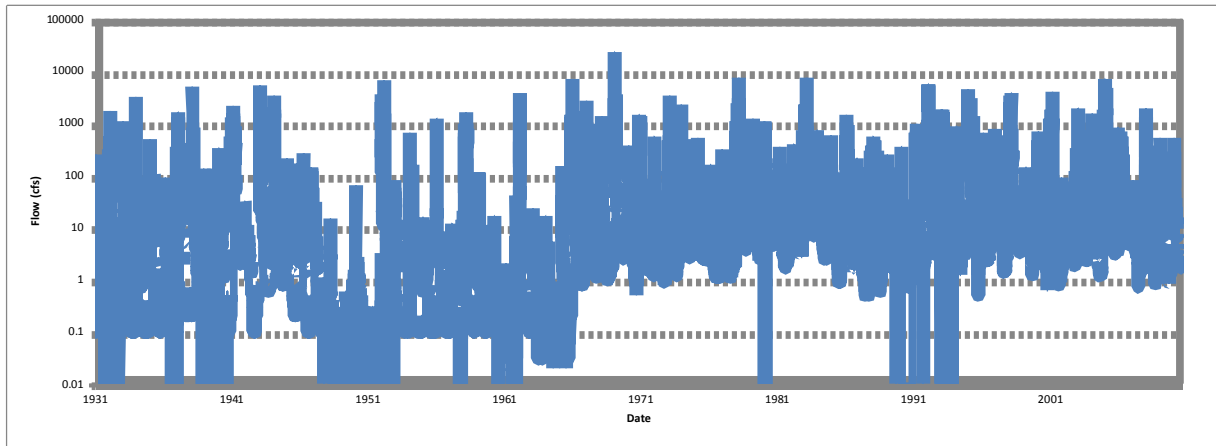
Figure 6-2. Daily Flow Time-Series for USGS 11105500/LACDPW F-130 Gage

Figure 6-2 and Figure 6-3 show the daily flow time-series for the two flow gage sites, with Figure 6-3 showing both gages for the common period of record. A logarithmic scale is used on the plots; values that fall at or below 0.01 cubic feet per second (cfs) represent zero reported flow. Flows at the two gages match fairly well in the winter; however, during the summer period flow at the upstream F-130 gage remains around 1 cfs, while flow at the downstream USGS gage drops to near zero. The difference is presumably due to evaporation and uptake by riparian vegetation, such as the non-native giant reed, *Arundo donax*.

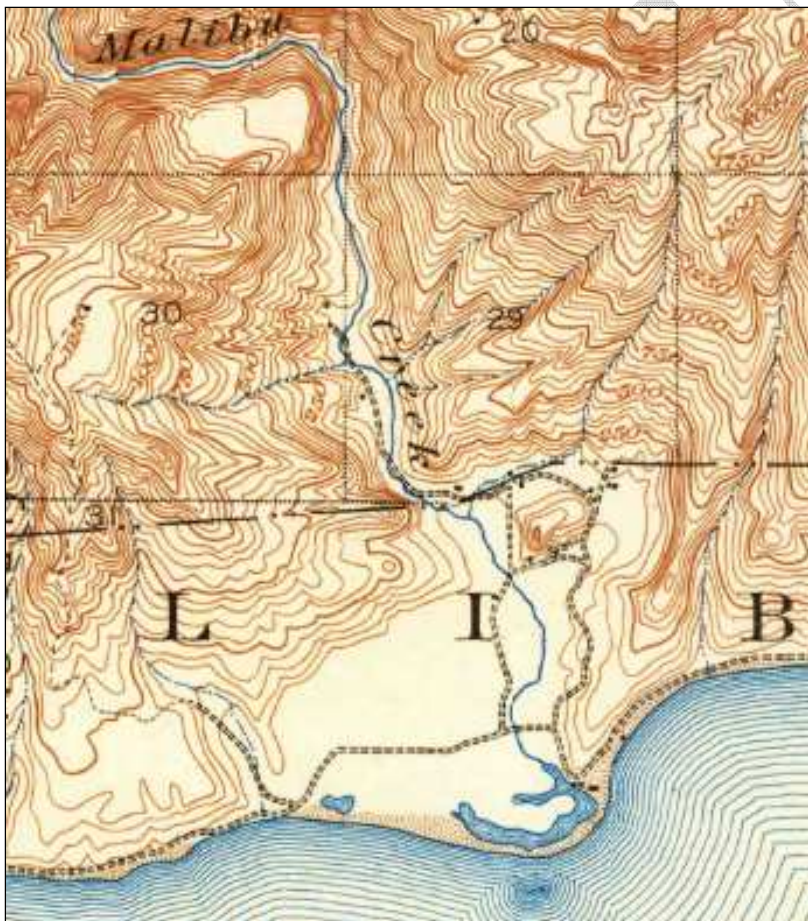
The geologic history of Malibu Lagoon is described in Ambrose and Orme (2000) and Moffatt & Nichol (2005). The form of the Lagoon represents a dynamic balance between sea level rise since the last ice age and high sediment supply due to uplift of the Santa Monica Mountains. In general, the Lagoon has been aggrading over time in concert with sea level rise of approximately 1.8 mm/yr. An image of the Lagoon prior to major disturbances is available from the 1903 topographic map of Calabasas Quadrangle (Figure 6-7). The map shows the Lagoon as closed, with a small area of open water. It is likely that ranching activities since the 1860s had increased sediment supply prior to this map.

**Figure 6-7. Malibu Lagoon, Detail from 1903 USGS 1:24,000 Map of Calabasas Quadrangle**

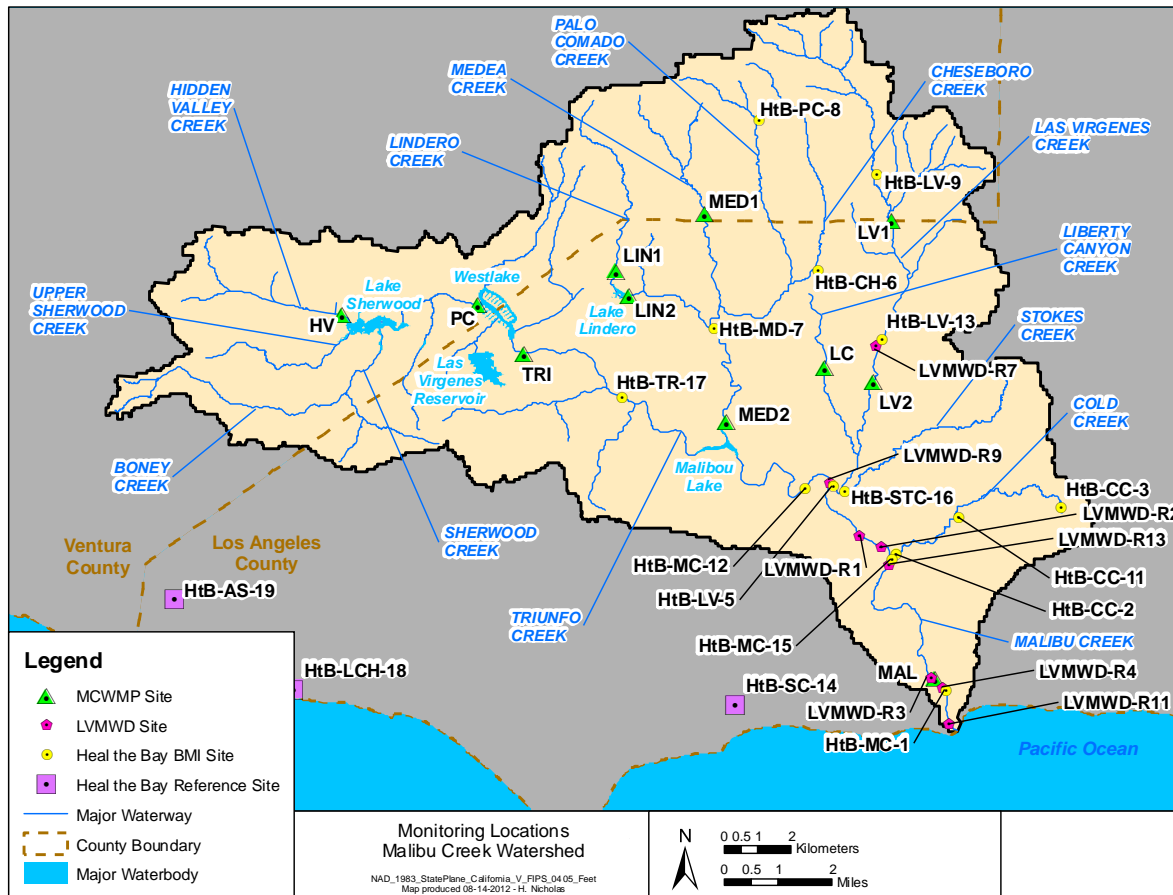
Figure 7-1. Monitoring Sites in the Malibu Creek Watershed and Adjacent Reference Sites

LVMWD has conducted sampling in Malibu Creek since 1971 in conjunction with their discharge permit. These sites are indicated by prefix “LVMWD” on Figure 7-1. The sampling sites focused on discharge points to the local creeks and downstream impacts and have consistently addressed bacteria, general physical parameters, and inorganic nutrients. In 2005, monitoring for heavy metals and organic compounds was added to the routine monitoring to address the California Toxics Rule.

The MCWMP was a multi-agency effort conducted under a Proposition 13 grant from February 2005 through February 2007 with the aim of establishing baseline water quality throughout the watershed. The sampling sites appear without prefix on Figure 7-1 (e.g., “LV1”).

As part of its MS4 permit, LACDPW conducts sampling at seven mass emissions stations, one of which is collocated with stream gage F130, in Malibu Creek just below the confluence with Cold Creek (coincident with HtB-MC15 on the map). This targets wet and dry events with the intention of estimating mass loading past the monitoring station.

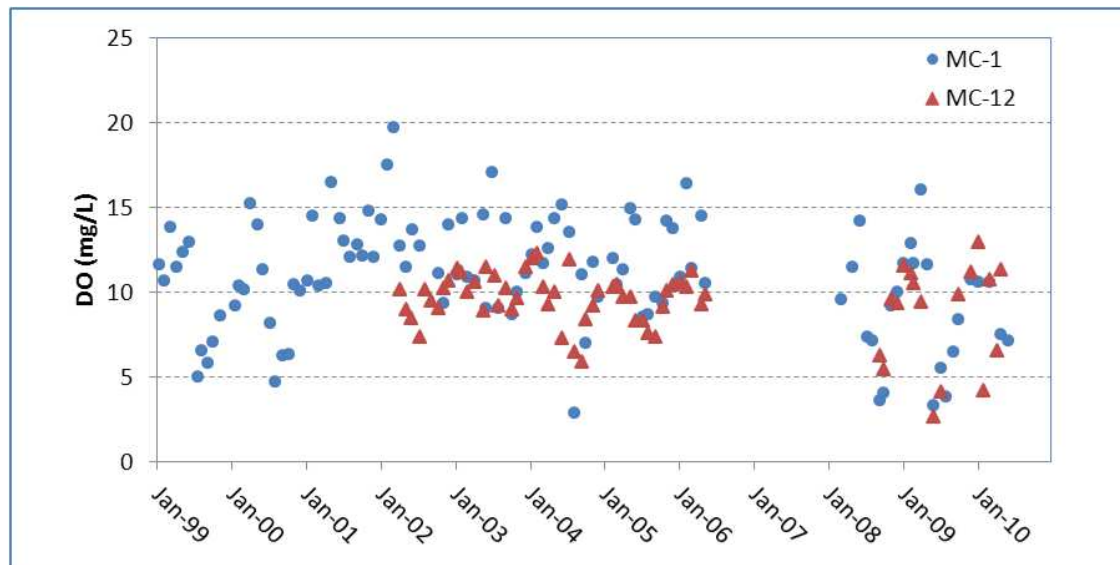
The DO samples in the main stem do not seem to show a clear trend over time, although observations less than 5 mg/L appears a little more frequent in recent years (Figure 7-3).

**Figure 7-3. DO Concentration versus Time at Malibu Creek Stream Team Stations 1 and 12**

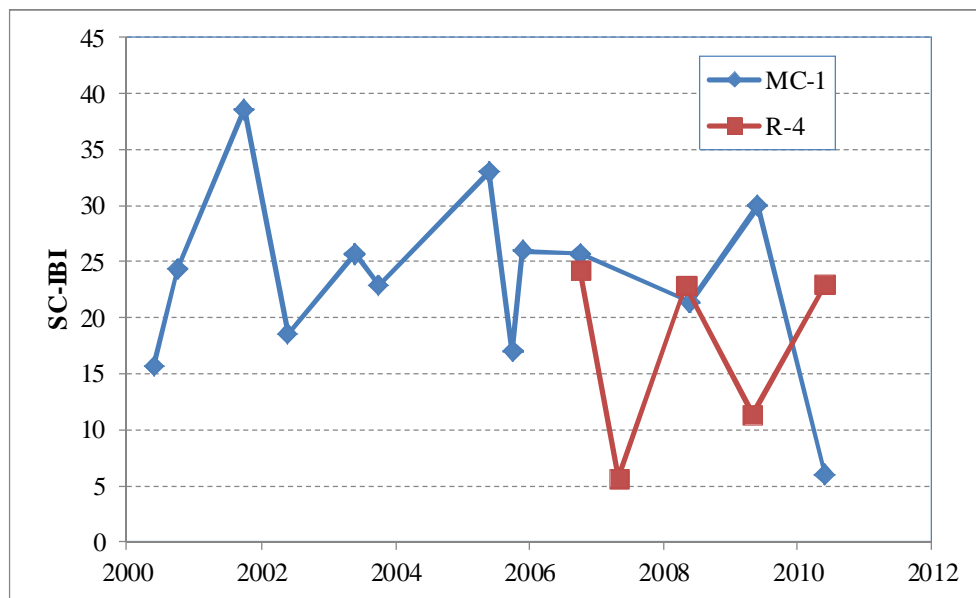
**Figure 8-8. SC-IBI Scores over Time at Malibu Creek near Mouth (MC-1 and LVMWD R-4)**

The SC-IBI scores vary from year to year. There does not appear to be any clear trend over time at the MC-1 station and nearby LVMWD R-4 station (Figure 8-8) and the median has remained around 20 - 25. A notable anomaly in the MC-1 results is the low score for spring 2010. In contrast, the R-4 station reported a more typical result for 2010, but yielded a very low score for 2007. Low values were also obtained by Heal the Bay in the Spring 2010 at MC-12 and MC-15 (3 and 6, respectively) while reference site scores dropped from 69 to 49 at AC-14 and from 57 to 47 at Lachusa. The 2010 results might thus be affected by weather or some other confounding factor.
